# MAPPING BEDROCK

## A New Tool to Identify Loss Potential in Vulnerable Landscapes

University of Wisconsin Extension/Discovery Farms

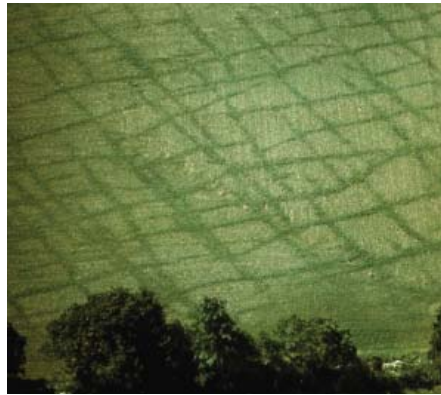
Figure 2. Bedrock fracture traces in a field.

The physical and chemical breakdown of limestone and dolomite results in a landscape characterized by sinkholes, caves and fractured bedrock (Figures 2 & 3). Applying municipal wastes and manure to land with these features runs the risk of contaminating drinking water.

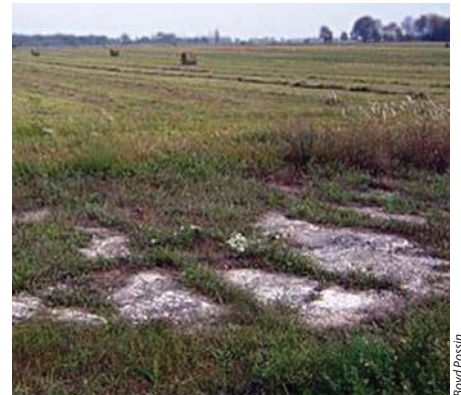
Figure 3. Bedrock at the surface.

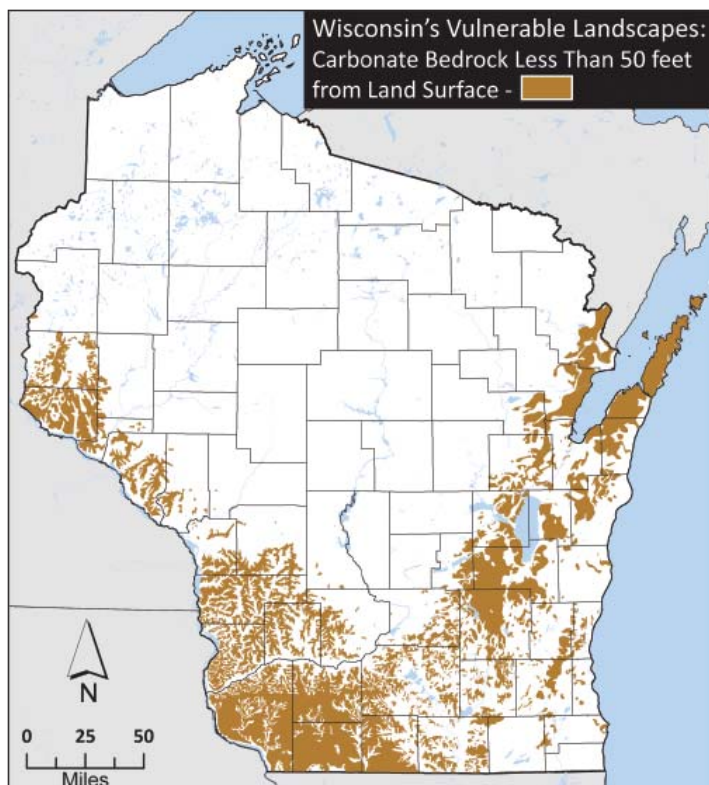
Figure 1. This map shows where thin, unconsolidated deposits overlie carbonate bedrock. These areas have a high potential for nutrient loss and groundwater contamination.

There's a V-shaped swath of Wisconsin where carbonate bedrock (limestone or dolomite) is near the land surface (Figure 1). Due to fractures in the bedrock, the landscape is vulnerable to groundwater contamination and nutrient loss from farm fields. In these areas well contamination is common, resulting in costly well replacement.

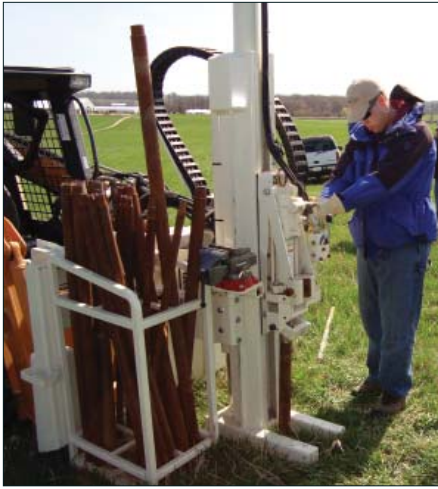
Figure 5. Discovery Farms used the Geoprobe to confirm accuracy of computer modeling.

Discovery Farms conducted fieldwork in Calumet County to confirm the accuracy of the 3-D model through the use of an impact drill called a Geoprobe® (Figure 5) as well as seismic refraction – using an impact device or explosion to generate a wave that travels through the earth’s surface. By measuring the speed of the wave using sensors on the land surface, geologists are able to calculate depth-to-bedrock.

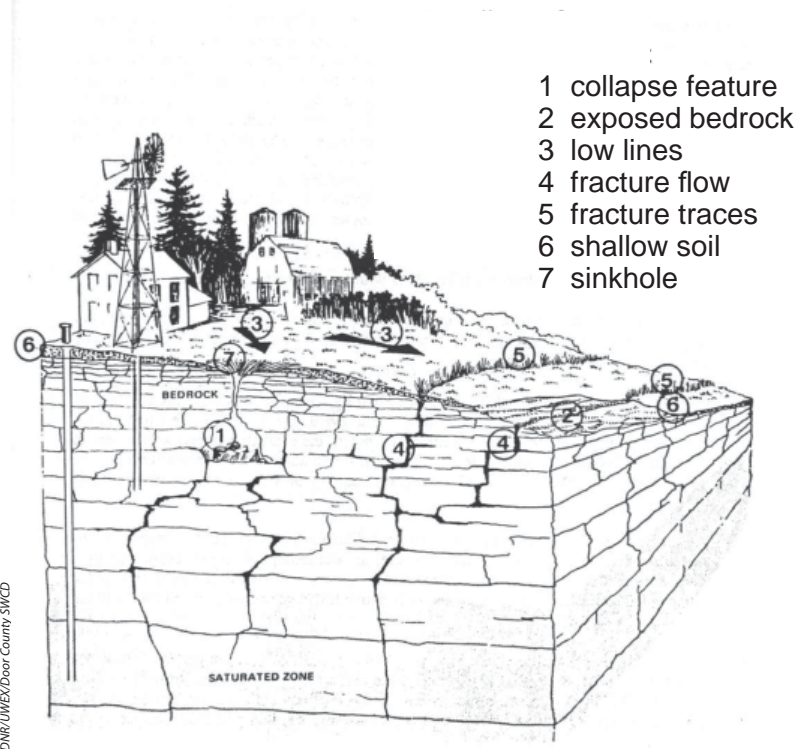
Figure 4. Features of a carbonate bedrock landscape.

Fractured bedrock presents a challenge to those managing agricultural lands because nutrients easily and rapidly move through these features, ending up in groundwater (Figure 4). The closer the carbonate bedrock is to the land surface, the higher the chance of losing nutrients. In addition, a large number of acres in agricultural production drain into closed depression areas with fractured bedrock, making it essential for critical site evaluation and sound nutrient management plans on a field-by-field scale.

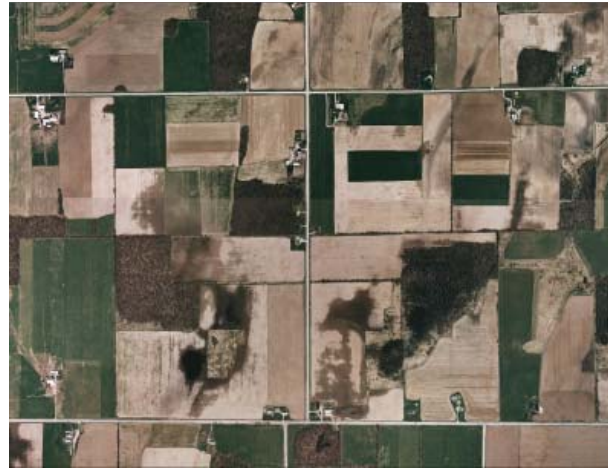
Figure 6. Aerial photograph of wet soils observed in low-lying areas where bedrock is “holding” water near the surface. Figure 7 shows depth-to-bedrock in the same area.

Combining rock layer data with well locations produced a high resolution depth-to-bedrock map. When the bedrock map was draped over aerial photographs, wet soils were observed in low-lying areas where bedrock holds water very near the land surface (Figures 6 & 7). Contaminated wells were common in these areas (Figure 8).

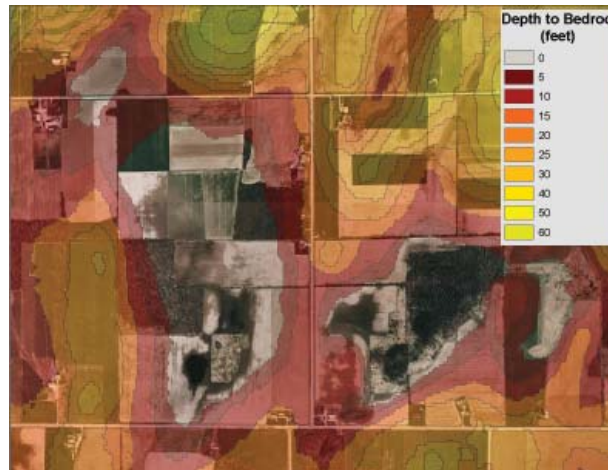
Figure 7. Depth-to-bedrock “draped” over aerial photograph seen in Figure 6. Each change in color represents a 5-foot interval in the depth-to-bedrock as indicated by the map legend.
