Understanding The Water Budget at Soaring Eagle Dairy - 4

Understanding Surface Water Runoff at SED

*Eric Cooley and Dennis Frame
UW Extension/Discovery Farms*

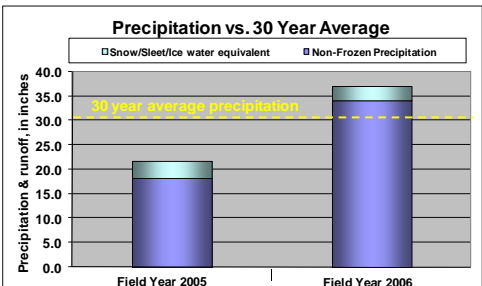
Field Year	Total Precipitation & Runoff (inches)	30-Year Average (inches)
Field Year 2005	21.7	30.5
Field Year 2006	36.6	30.5

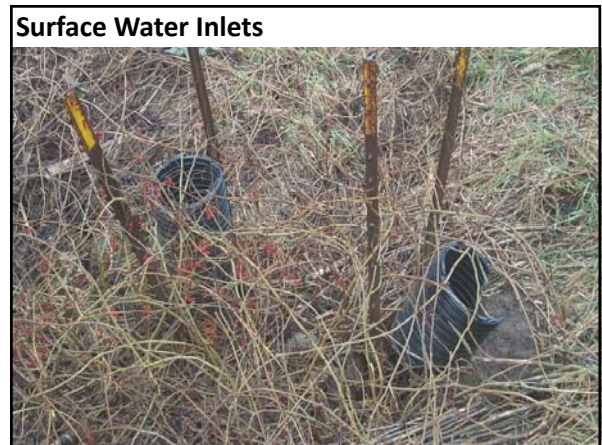
Extended flow and freezing temperatures caused the runoff to freeze downstream of the site.

Pools formed causing an ice dam.

Once established, water filled the flume with ice.

Discharge measurements could not be considered accurate, so samples were not taken.

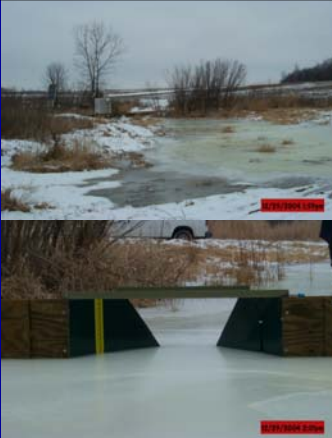
Flume remained encased in ice until early March.

After the ice was removed, debris remained downstream causing water to backup during surface water events.

Temporary fixes and lower surface water runoff volumes allowed accurate flow measurement and water sampling to resume in early April 2005.

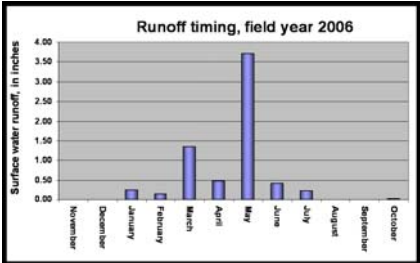
- Majority occurred in the spring when soils were saturated

Month	Surface water runoff (inches)
November	0.00
December	0.00
January	0.00
February	0.00
March	1.3
April	0.5
May	3.6
June	0.4
July	0.3
August	0.00
September	0.00
October	0.00
